Rot Repair:

Weathervane Wood Window Sill

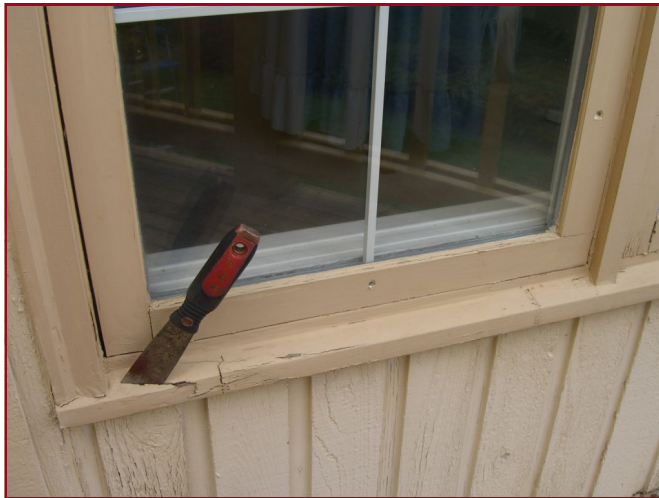
One third of the sill on this window was rotten and soft to the touch.

After removing the window sash, we cut and removed the rotten wood, leaving behind only what was still solid.
